**RE: GEOTECHNICAL INPUT TO CIEMAS STUDY**

## 1 Background Information

## 2 Structural Set Analysis

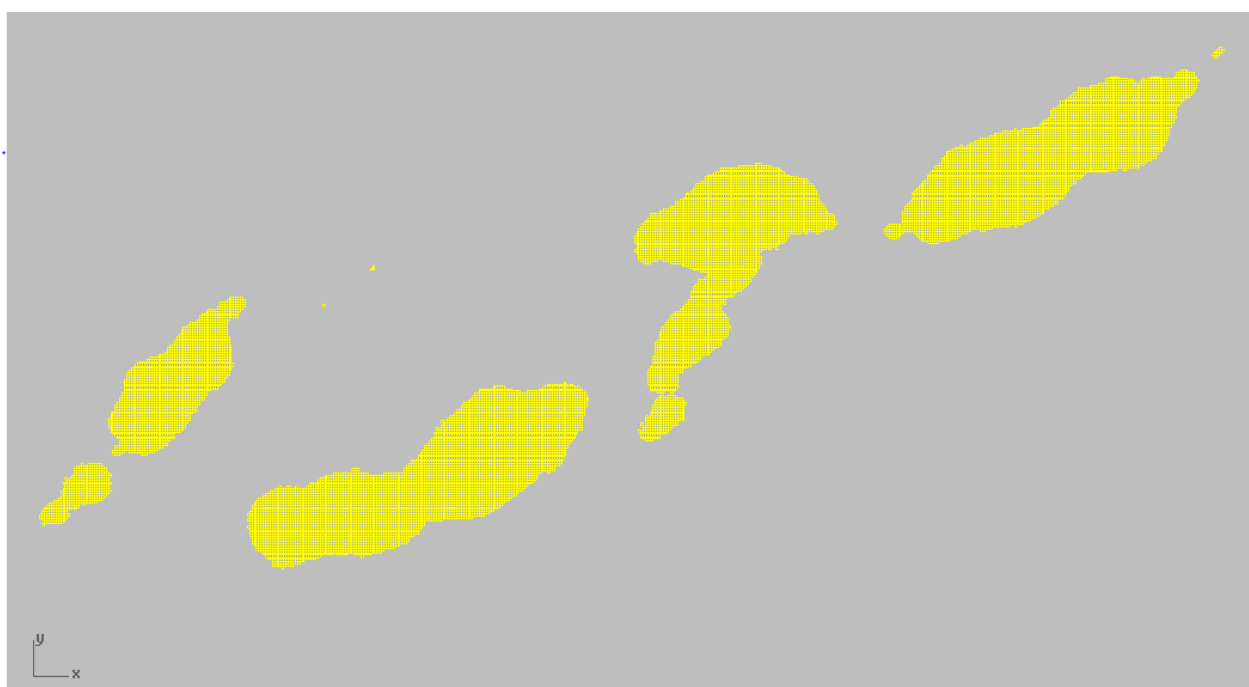
**Figure 1 Conceptual Pit Design Shell Outlines – Plan View**

GCE has completed an initial review of the potential impact of the major structural sets outlined in Table 1 with respect to the preliminary pit design shells provided by Mancala. The pit design shell outlines are shown in yellow in Figure 1 below.

As shown in Figure 1, the proposed pits are generally orientated along a NE/SW strike, with the major walls oriented NE/SW and dipping to the SE and NW on either side of the pits. The end walls are generally NW/SE striking and dip to the NE and SW at either end of the pits.

The potential impact of the major structural sets outlined in Table 1 with respect to the preliminary pit design shells shown in Figure 1 is summarized as follows:

Structural Set 1 is a dominant structural orientation in the data set and consists of steep south to south-south west dipping structures. Set 1 is evident in all structure types across the three major rock types in the data set. This set has the potential to contribute to topple style failure on the southern walls of the proposed pits. The likelihood and potential for topple failure requires further detailed assessment and depends on the pit wall angles, the spacing and persistence of structural discontinuities (block size) and the shear strength properties of the Set 1 defects.

Set 1 is unlikely to be associated with discrete planar wedge failure on this structural set alone due to it being relatively steeply dipping and unlikely to daylight in the pit walls. It may however, provide a bounding release structure for potential wedge failure on the eastern pit walls, associated with Structural Set 3.

Structural Set 2 is a similarly dominant structural orientation in the data set and consists of steep north to north-north west dipping structures. Set 2 is evident in all structure types across the three major rock types in the data set. This set has the potential to contribute to topple style failure on the northern walls of the proposed pits. As with Set 1, the likelihood and potential for topple failure requires further detailed assessment and depends on the pit wall angles, the spacing and persistence of structural discontinuities (block size) and the shear strength properties of the Set 2 defects.

As with Set 1, Set 2 is unlikely to be associated with discrete planar wedge failure on this structural set alone due to it being relatively steeply dipping and unlikely to daylight in the pit walls. It may however, provide a bounding release structure for potential wedge failure on the eastern pit walls, associated with Structural Set 3.

Set 3 has the potential to contribute to planar and wedge style failure on the eastern walls of the proposed pits. The overall potential for wedge failure is limited by the flat dip of the Set 3 structures which ranges from approximately 15° to 35°. If wedge failure is to occur, the friction angle of the defect(s) must be less than the dip of the sliding plane. GCE understand that no test data regarding defect shear strength properties is available at this stage however, friction angles of less than 30° are typically associated with the presence of soft infill materials on the defect surfaces.

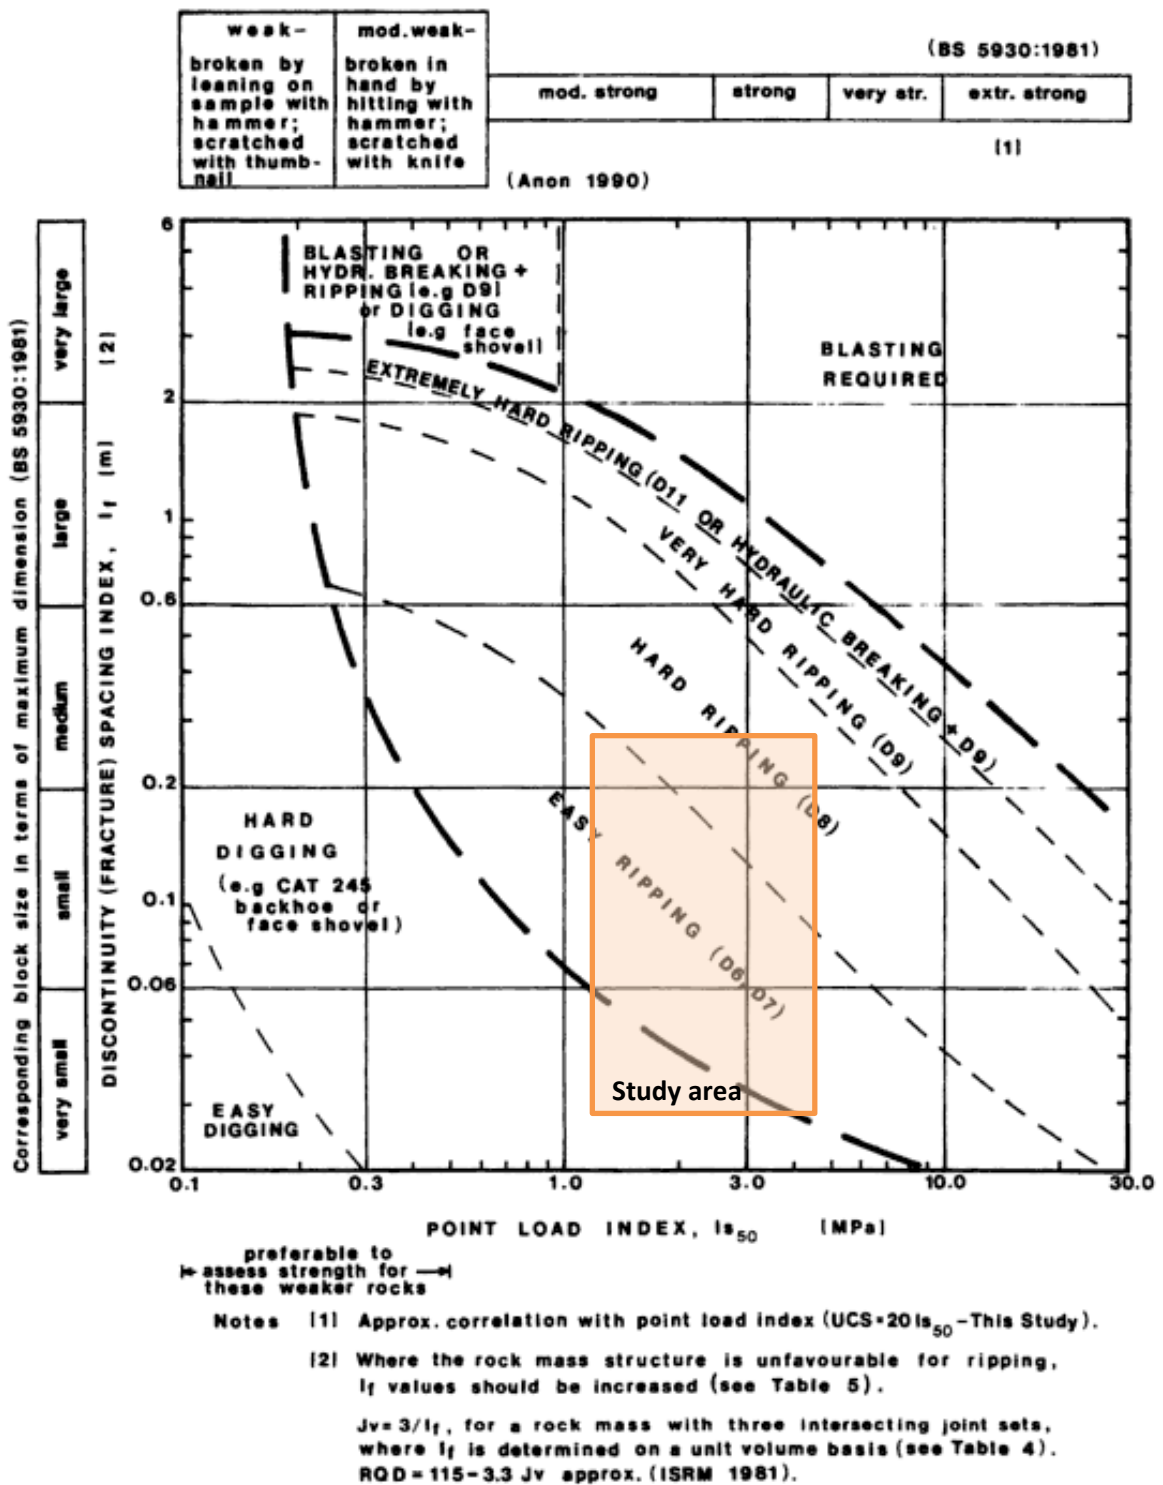
Figure 2 Pettifer-Fookes Excavatability chart<sup>2</sup>

There are a number of published charts that relate rock strength and excavation method. The range of Is<sub>50</sub> from the study are have been plotted on the chart in Figure 2, to illustrate the likely excavatability of the rock. An estimate was made of the corresponding block size from the range of RQD data presented in the drill logs.

Easy ripping can be expected in rocks with Is<sub>50</sub> values below 3 MPa (R0-R3) and very small to small block size (RQD < 50%). To gain some appreciation of the limits of excavatability (easy ripping), the downhole depths in the drillholes where these two conditions are present were evaluated.

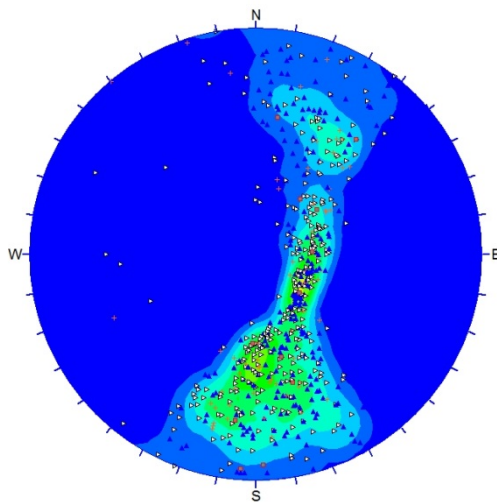
### All Data – No Terzaghi Correction

- FV [12]
- ▲ SHR [272]
- ▶ VL [317]
- + VN [80]

Equal Angle  
Lower Hemisphere  
681 Poles  
655 Entries

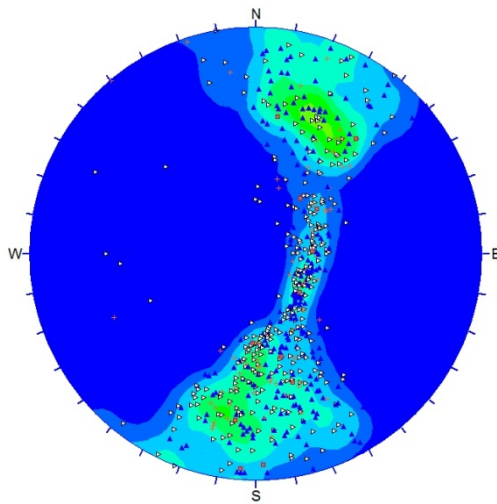
### All Data – Terzaghi Corrected

- FV [22]
- ▲ SHR [513]
- ▶ VL [554]
- + VN [137]

Equal Angle  
Lower Hemisphere  
1228 Poles  
655 Entries

The structural data was analysed separately for each lithology and structure type included in the data set. The Terzaghi correction was applied to structure contour plots to account for drilling bias. The stereonet used in the structural analysis are included in Appendix A. The stereonet in Appendix A were used to identify the major structural elements and define structural sets as outlined in Table 1.

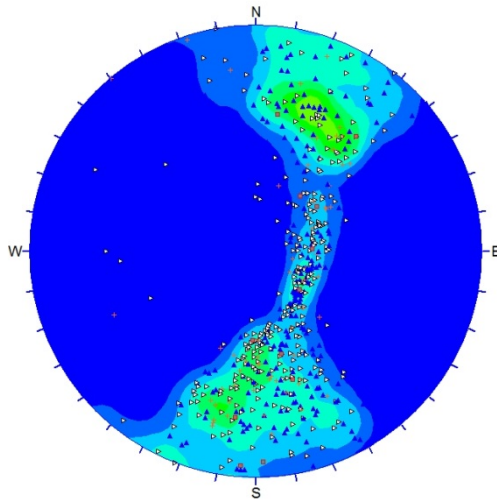
### VBR – Terzaghi Corrected

- FV [22]
- ▲ SHR [471]
- ▷ VL [529]
- ✦ VN [134]

Equal Angle  
Lower Hemisphere  
1158 Poles  
615 Entries

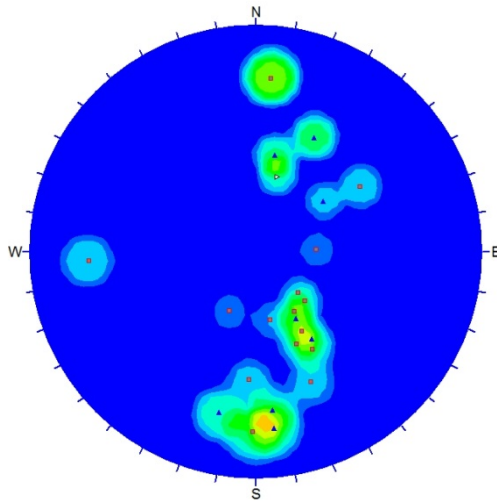
### TUFF – Terzaghi Corrected

- SHR [21]
- ▲ VL [13]
- ▷ VN [1]

Equal Angle  
Lower Hemisphere  
37 Poles  
24 Entries

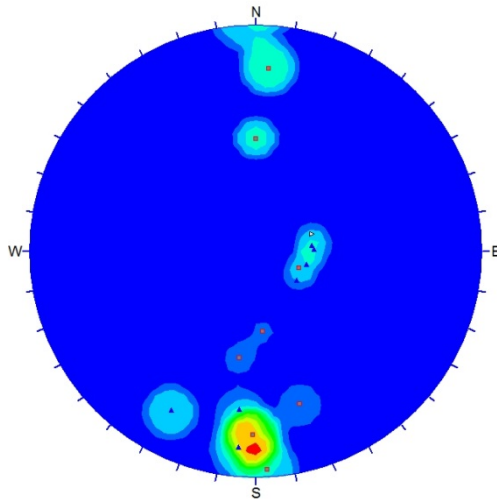
### LPS – Terzaghi Corrected

- SHR [20]
- ▲ VL [11]
- ▷ VN [1]

Equal Angle  
Lower Hemisphere  
33 Poles  
16 Entries

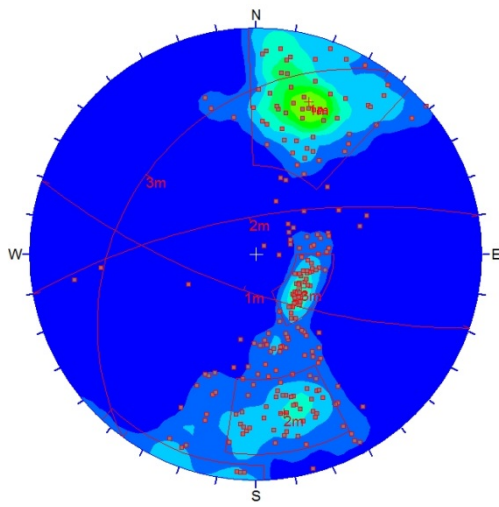
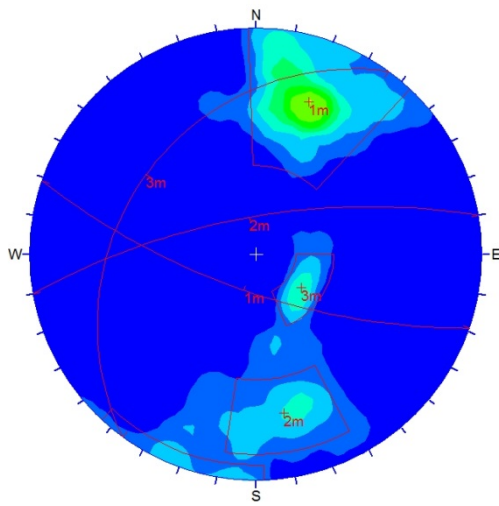
VBR - SHR

Equal Angle  
Lower Hemisphere  
471 Poles  
243 Entries

1 m	71 / 199
2 m	71 / 350
3 m	28 / 306

Rock Unit	Structure Type	Major Structural Set Orientations			# of Measurements in Data Set	Comments
		Set 1	Set 2	Set 3		
VBR	SHR	71/199	71/350	28/306	243	Insufficient data to define specific set orientation(s)
	VL/VN	62/214	63/358	28/257	360	
	FV	Present	83/003		12	
TUFF	SHR	Present	Present		15	
	VL/VN	Present	Present		9	
LPS	SHR	Present	Present		8	
	VL/VN	Present		Present	8

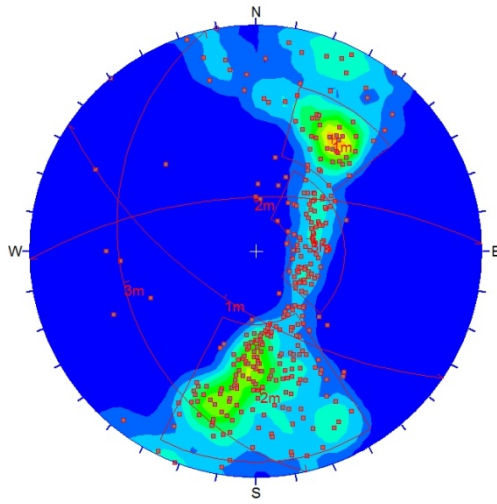
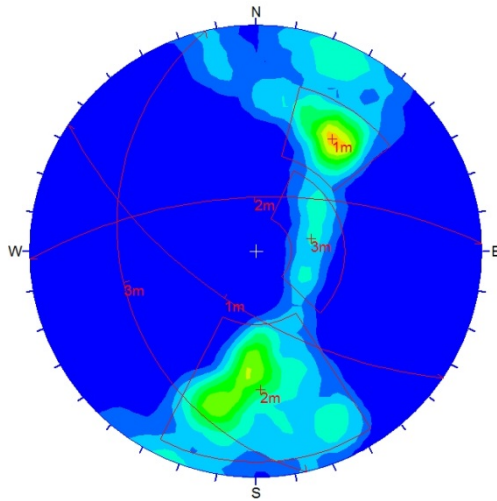
VBR – VL/VN

Equal Angle  
Lower Hemisphere  
663 Poles  
360 Entries

1 m	62 / 214
2 m	63 / 358
3 m	28 / 257

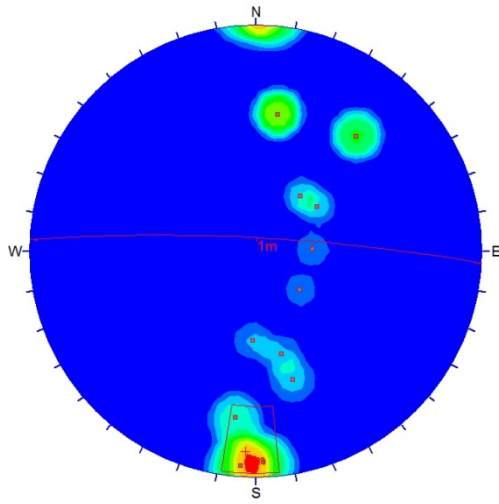
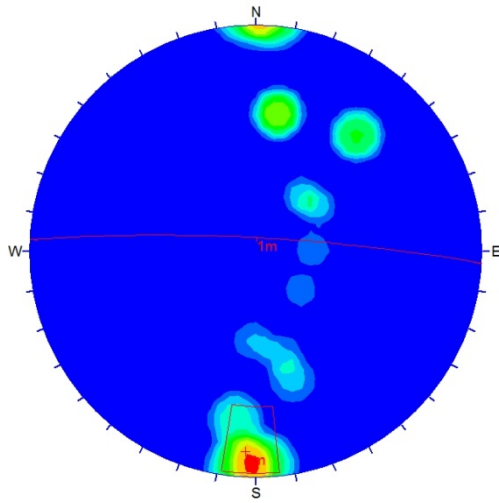
VBR – FV

Equal Angle  
Lower Hemisphere  
22 Poles  
12 Entries

1 m 83 / 003

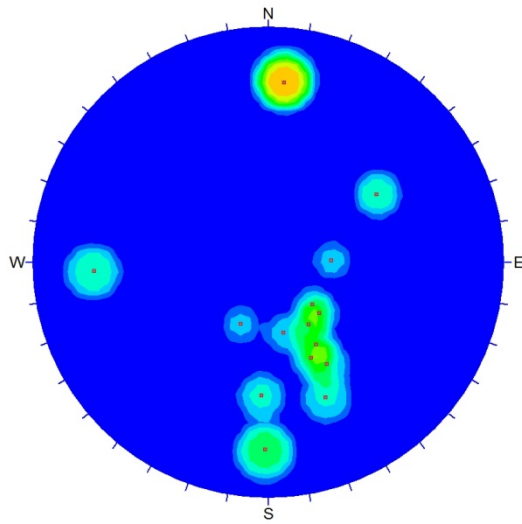
TUFF – SHR

Equal Angle  
Lower Hemisphere  
21 Poles  
15 Entries

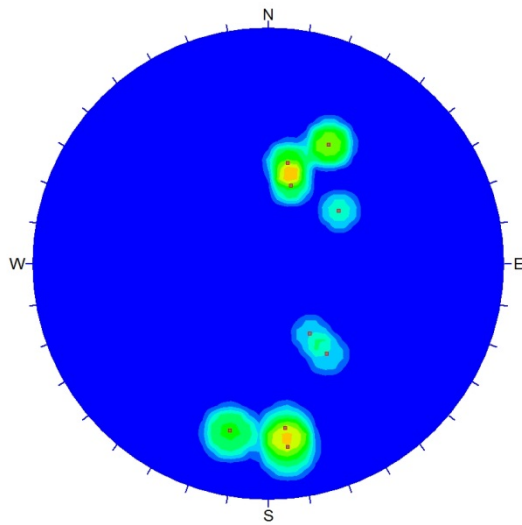
TUFF – VL\_VN

Equal Angle  
Lower Hemisphere  
15 Poles  
9 Entries
